TP 14090E

***Louis S. St. Laurent Propeller
Damage Analyses***

Prepared for
Transportation Development Centre
Transport Canada

April 2003

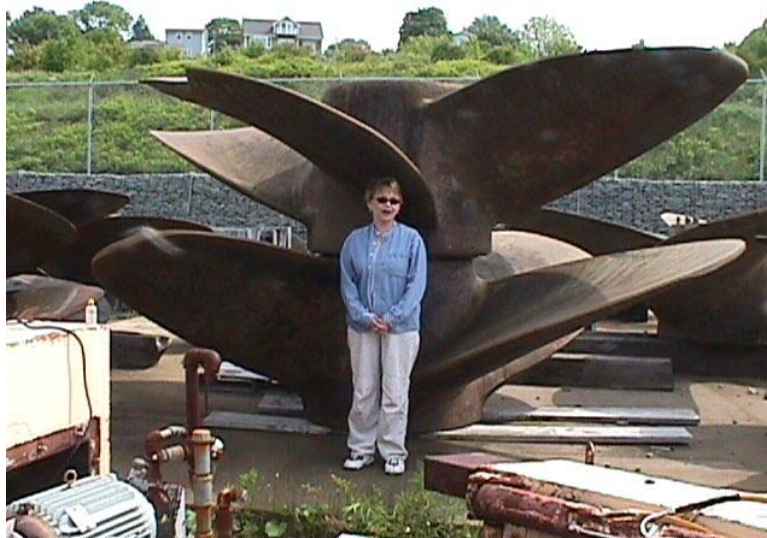
Figure 2.1: Damaged Propellers

Moulds of the damaged blades of two old design propellers (Figure 2.1) were taken and material samples were collected by BMT FTL, with partial funding support from TC. The moulds and samples provide the essential data for the work in this project.

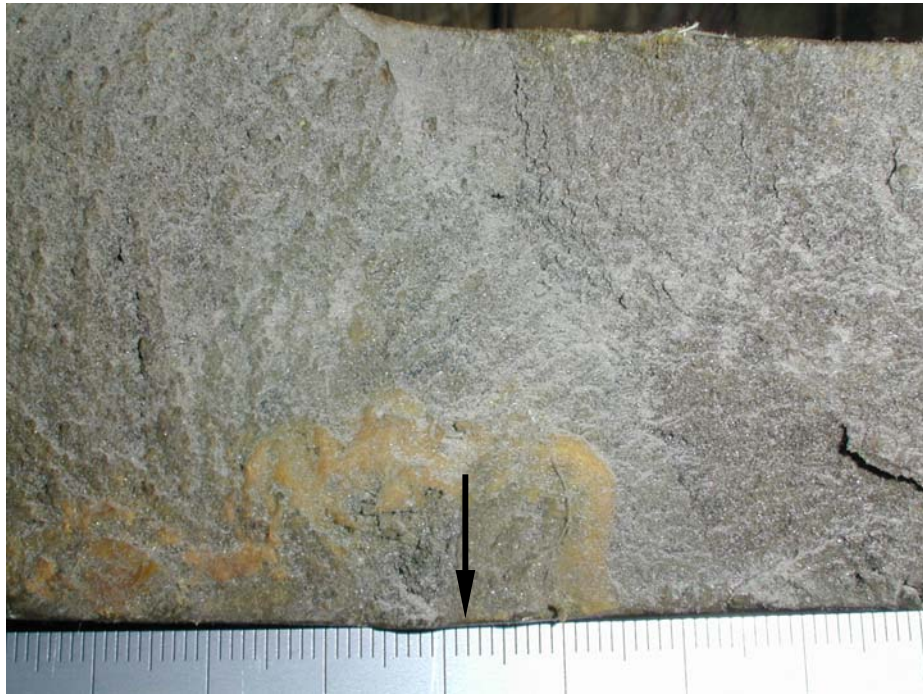
(a)

Macroscopic scales are normally best for observing fatigue crack growth. In this case there is no evidence of fatigue crack growth associated with the brittle fracture initiation. As there is no visible link to a defect (flaw) for the second initiation site, this region was subject to closer and higher magnification forensics. The local fracture initiation region marked by the black arrow in Figure 3.1(b) was cut out for this purpose. The fracture surface was cleaned in 50/50 HCl/distilled water solution with Rodine as an inhibitor to remove any oxide. Examination performed with the aid of the stereoscope indicated the initiation was indeed linked with a smaller casting defect. Figure 3.3 shows the cut out sample with the arrow pointing to the fracture initiation point (black arrow). Also observed on the extracted sample is a surface layer of metal, 2 to 4 mm thick, on the surface of the propeller blade that has a different texture than the rest of the fracture.

Figure 3.1: Fracture Initiation Points

Note: Fracture initiation points are marked by black arrows. The yellow substance on the fracture surface is a remnant of the molding material.

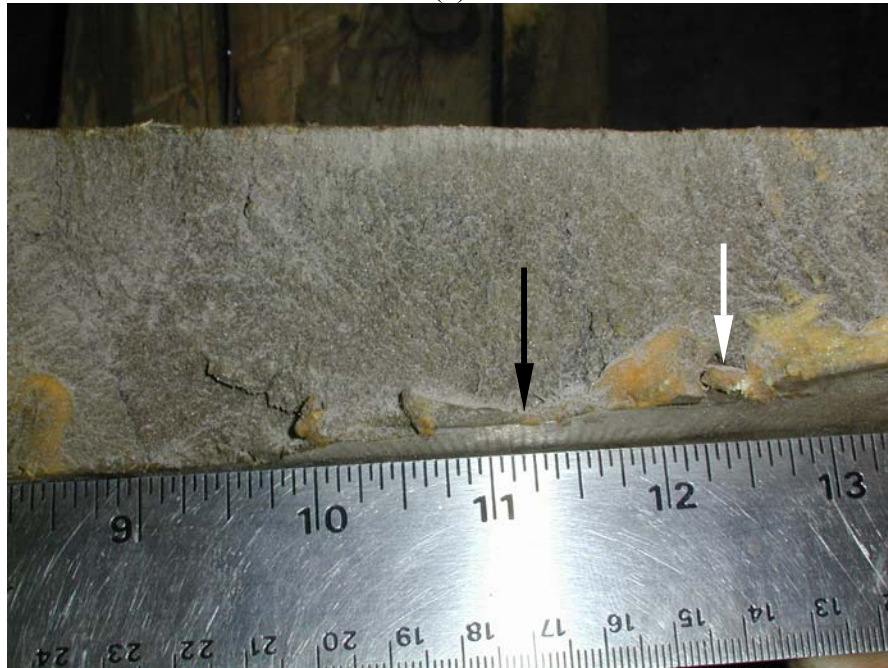
(b) white arrow points to a casting defect.

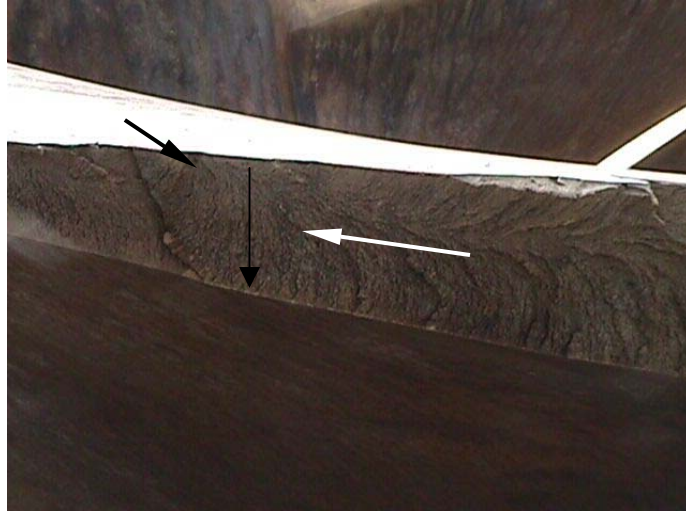
Figure 3.2: Lower Magnification of the Fracture

Note: The chevrons indicate the direction of fracture propagation to the right. The white arrow points to the initiation region and the black arrow in Figure 3.1(a) marks the initiation point.

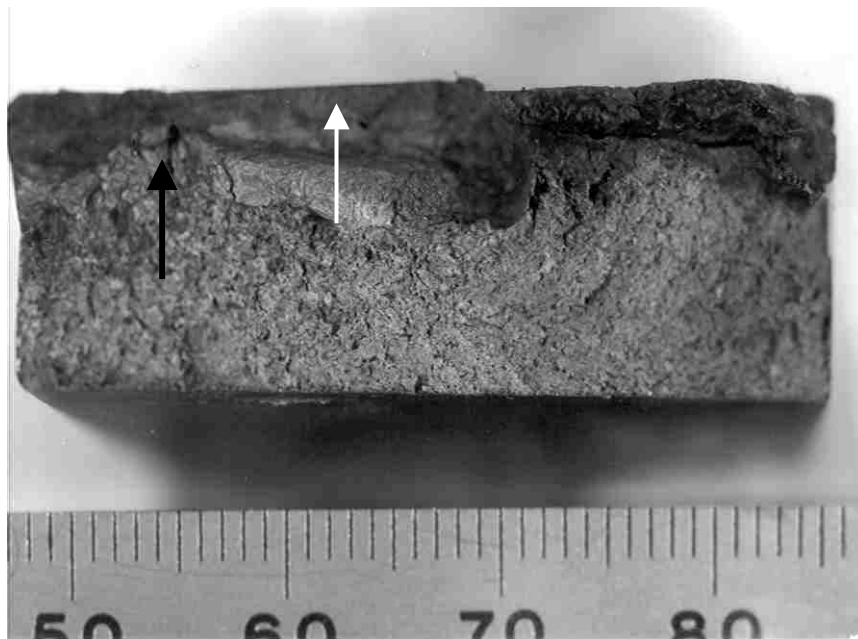
Figure 3.3: Close-up of Fracture Initiation Region in Figure 3.1(b)

Note: The HP side of the blade is on top. The layer of metal with a different texture is shown by the white arrow.

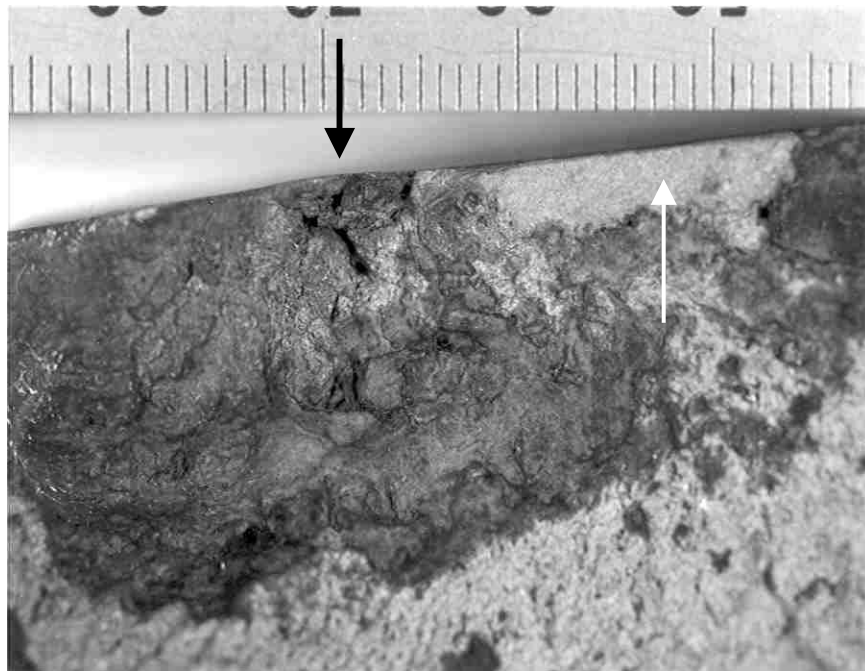
Figure 3.4: Close-up of Fracture Initiation Region in Figure 3.1(a)

A close-up of the main initiation point in Figure 3.1(a) is presented in Figure 3.4. The black arrow identifies the associated casting defect. Once again, a different texture is observed on some regions of the surface.

Note: The layer of metal with a different texture is shown by the white arrow.

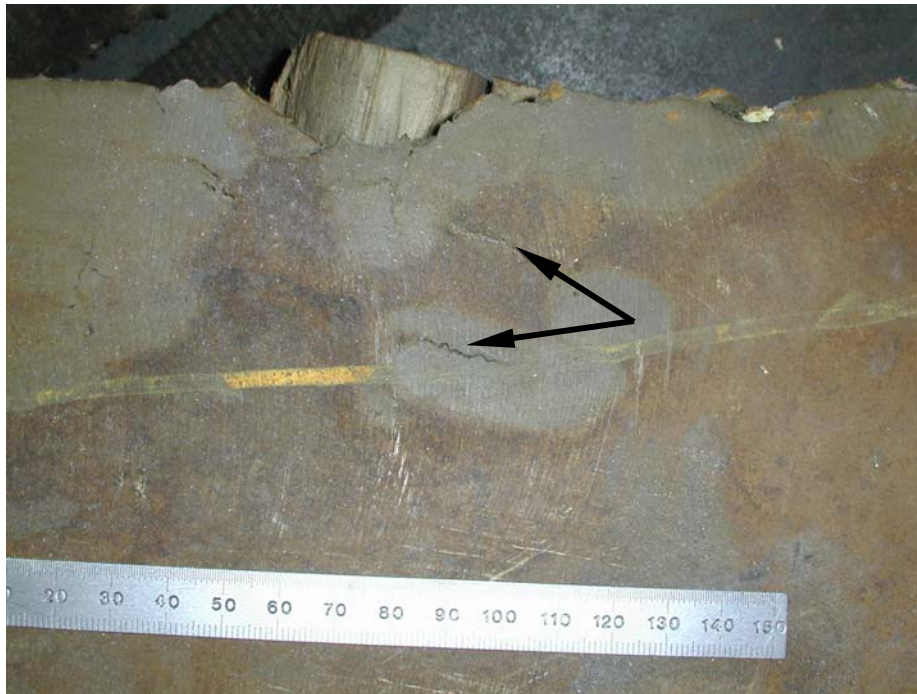
Figure 3.5: Examples of Cracks Close to the Fracture on the HP Side of the Blade

Figure 3.5 displays an example of the subsidiary cracks on the HP side (the face) of the blade in the current investigation. By contrast, there was no cracking observed on LP side of the blade close to the fracture at macroscopic levels (see Figure 3.6).

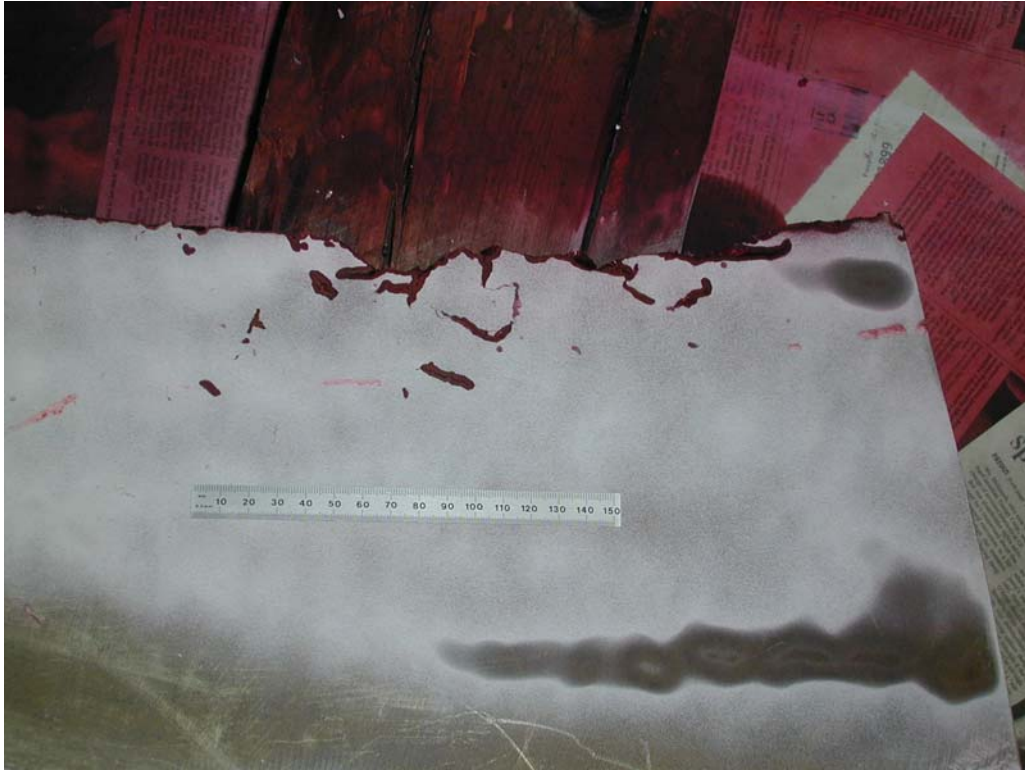
(a)

Figure 3.7: LPI Results on the LP Side of the Blade

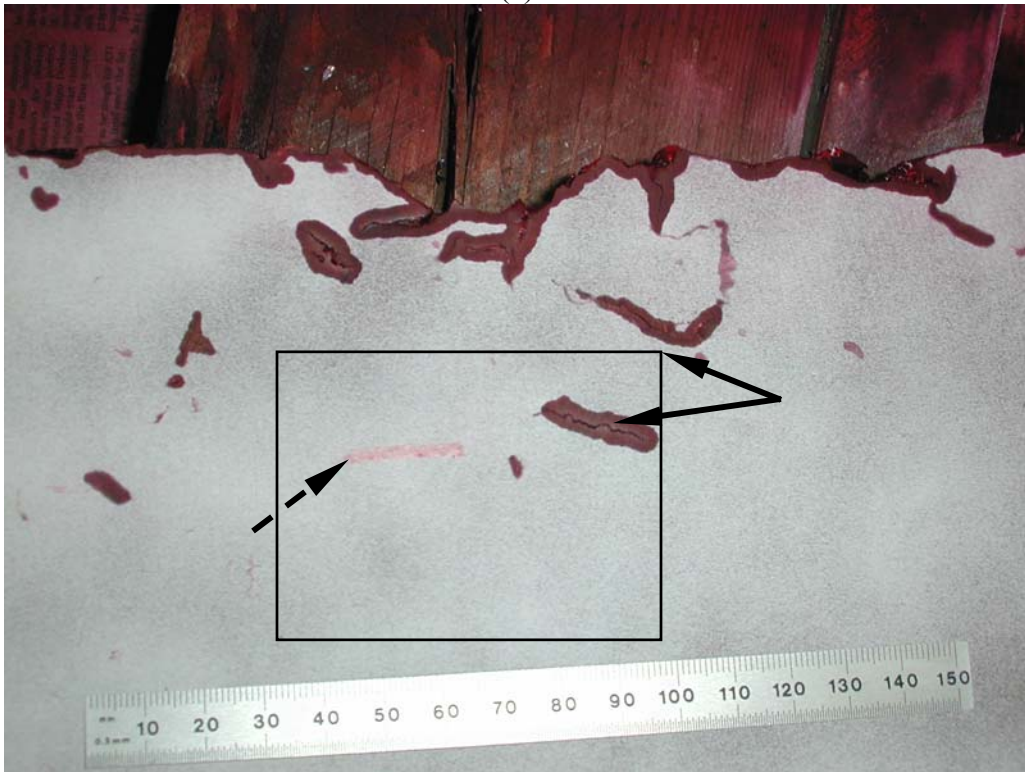
(b) same region shown in Figure 3.5, and the two arrows show the cracks visible in Figure 3.5, while the dashed arrow shows a new detection.

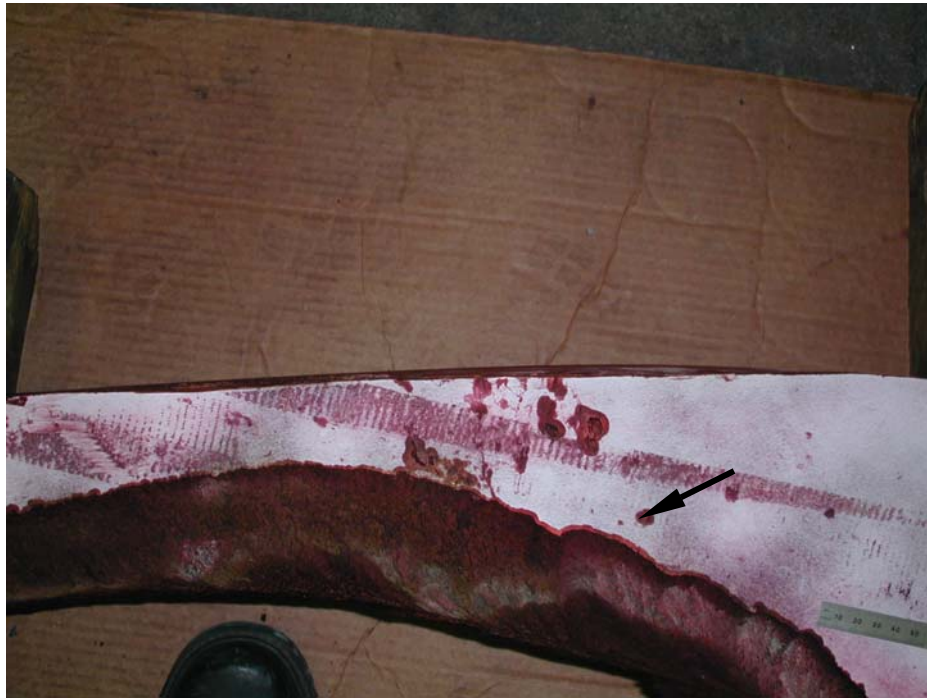
Figure 3.8: LPI Results on the HP Side of the Blade

Note: Mechanical damage is marked by the arrow.

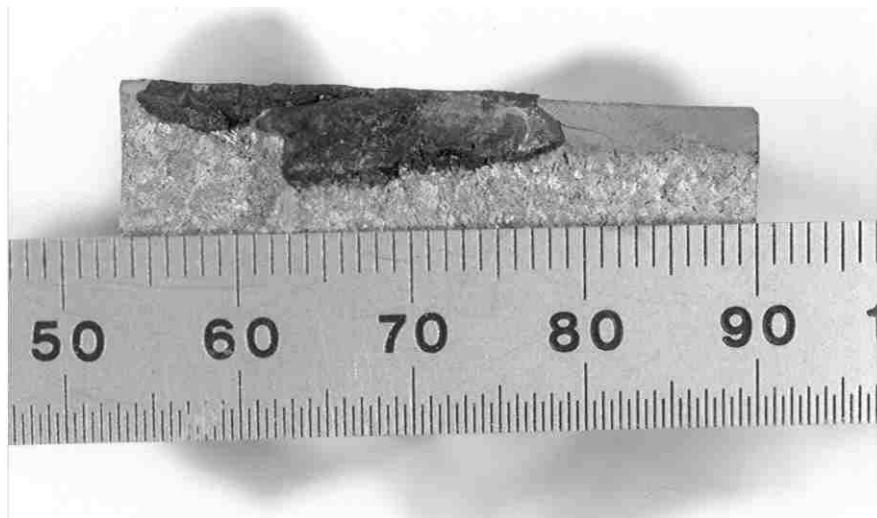
Figure 3.9: Fracture Sample Produced at Liquid Nitrogen Temperature

The attempt to open up the large crack after immersion in liquid nitrogen was successful as presented in Figure 3.9. The darker region is the “pre-existing crack” and the bright region is the brittle fracture surface produced when breaking the specimen. A different texture of the fracture surface is seen adjacent to the blade surface similar to those presented in Figures 3.3 and 3.4.

Note: A layer of metal with a different texture can be seen at the blade surface.

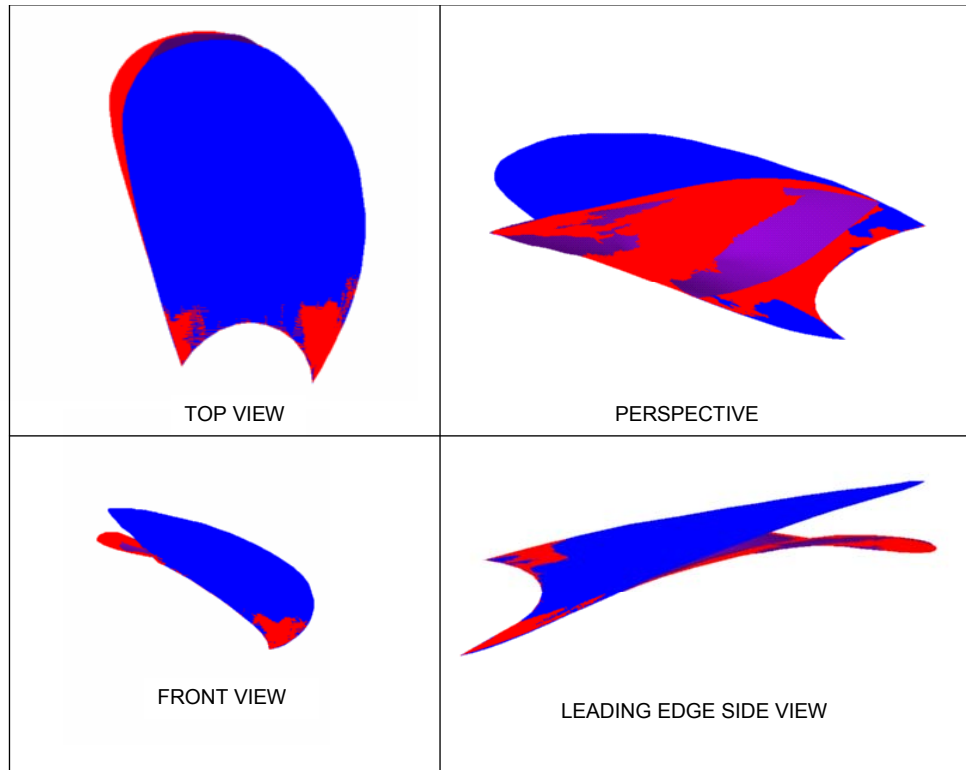
Figure 5.3: Original (Blue) and Deflected Shape (Red) of Blade 1

Blade	Actual from Castings	
	Tip deflection (mm)	Twist at 400 mm from tip (°)
Starboard 1	302.20	5.27
2	198.14	1.68
3	193.76	-0.88
Port 4	59.49	-0.92
5	Broken	Broken

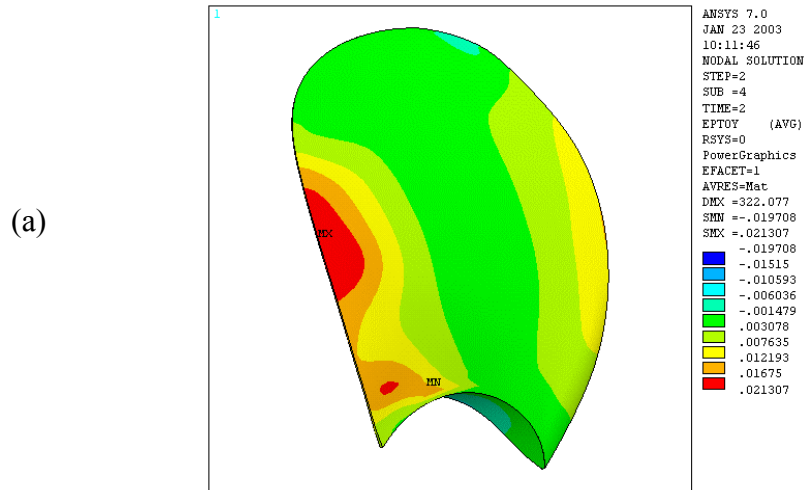
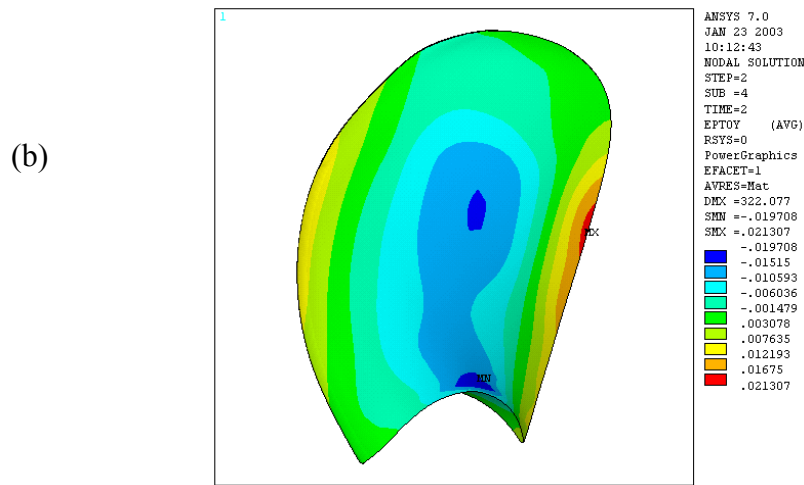
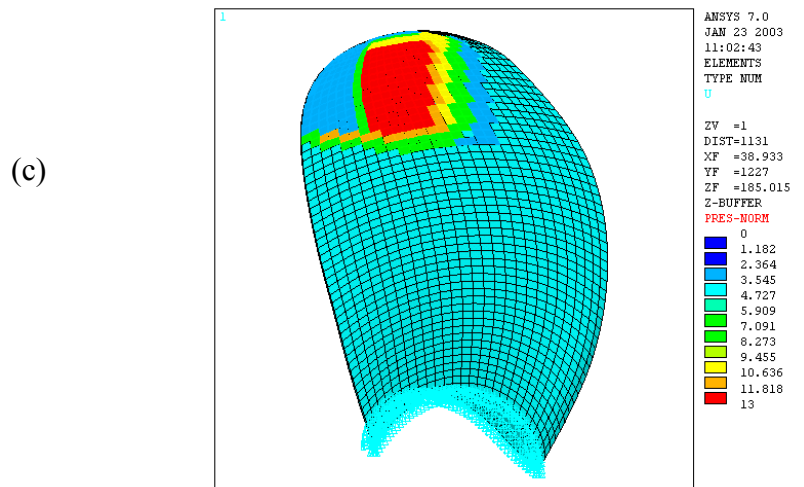
Figure 5.7: (a) and (b) Residual Strains Resulting from (c) Applied Pressure Loading (MPa) for Starboard Blade 1

It can be seen that in all cases the plastic deformation (strains) extend over much of the propeller, from root to tip. Thus, the total deflection listed in Table 5.1 is the result of accumulation of deflection along the length of the blade rather than damage concentrated at the tip – this can also be seen in the comparisons of original and deflected shapes. There is a tendency for the leading and trailing edges to show higher residual strains than the centre of the blade.

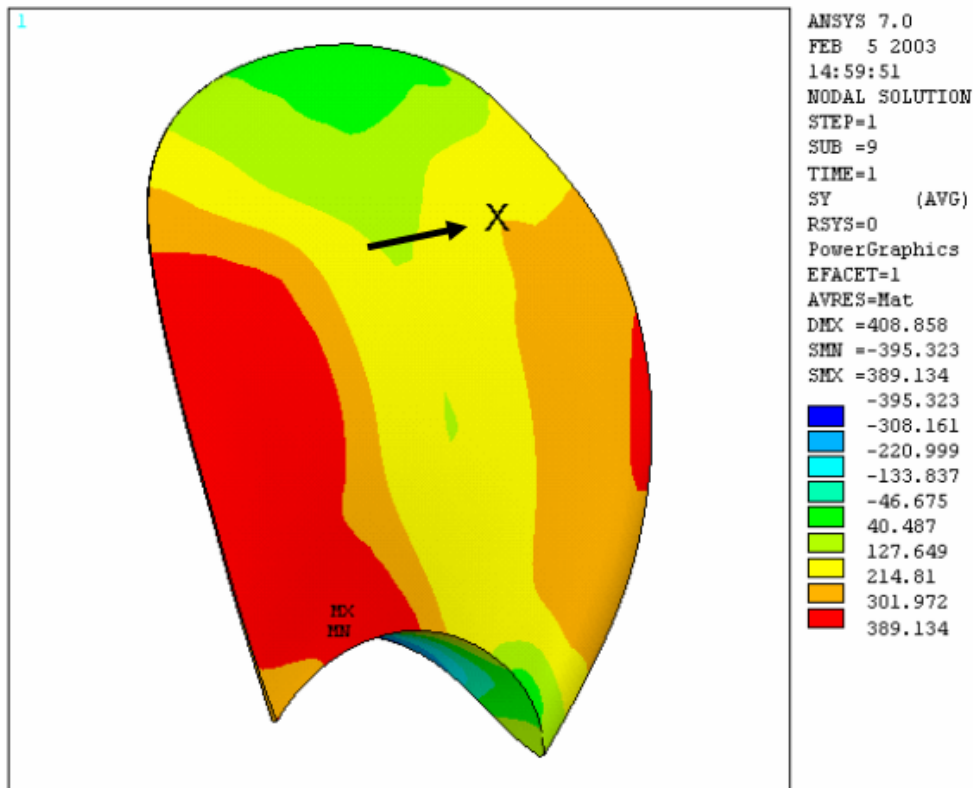
Figure 6.7: Approximate Location of Initial Fracture and Stress Distribution from Blade 1

As noted above, all the blades for which loadings could be derived saw stresses considerably in excess of yield and much of the way towards ultimate for the propeller material. A comparison can be made of where the failure initiated with the locus of maximum stress on Blade 1, the most deformed of the unbroken blades, as shown in Figure 6.7.
